# Subterranean termite infestation in buildings

## protecting timber, buildings and furniture

### Termites 3

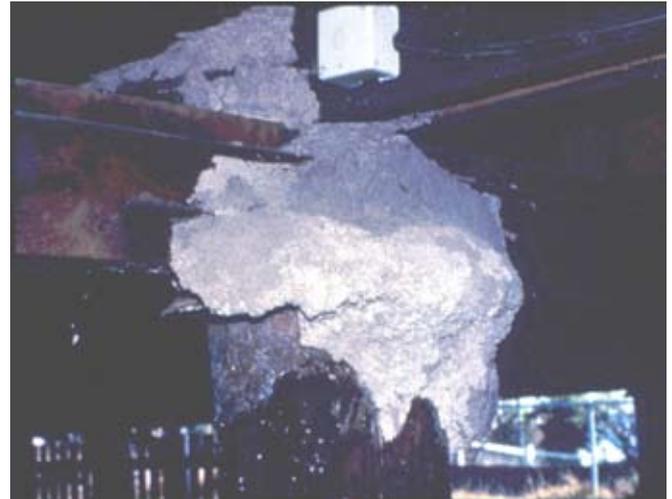
Figure 1. Physical barrier (termite shield) bridged by subterranean termites.

Methods employed in the erection of physical barriers during building construction are detailed in the Australian Standard AS 3660 series. These barriers impede and discourage termite entry into buildings. Termites can build around physical barriers (Figure 1), but are more readily detected during routine inspections.

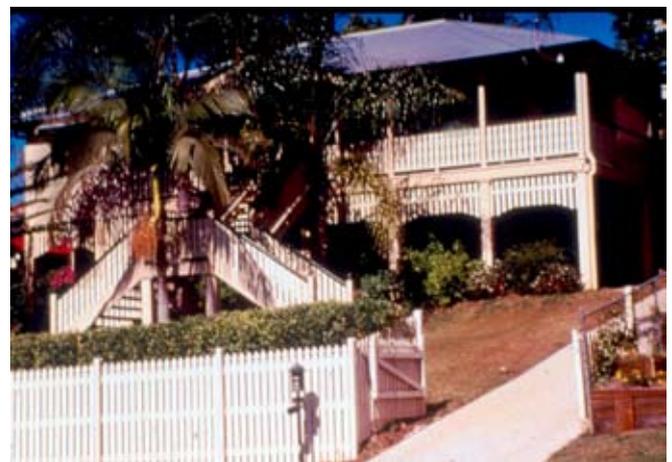
Figure 2. For suspended timber floors, termite shields and routine inspections provide adequate protection.

For suspended floors, termite shields (caps or strip shielding) have, for many years, been placed on foundation walls, piers, stumps, and other substructures to isolate the upper parts of the building from the substructure (Figure 2). Care should be exercised when enclosing the substructure area not to bridge termite shields superstructure. Stainless steel mesh can be used to provide these physical barriers (Figure 3).

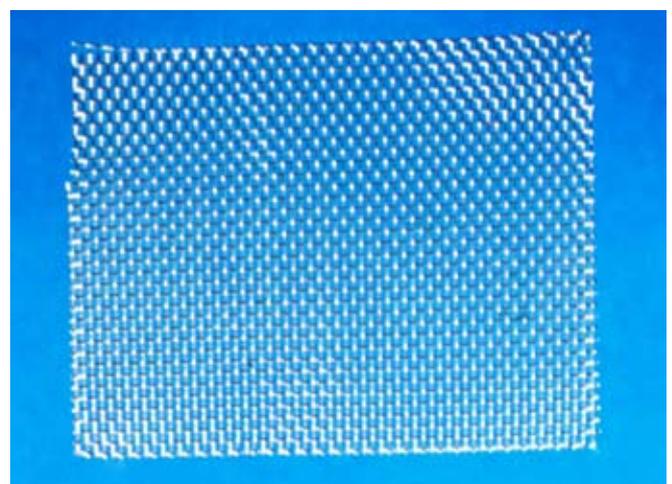
Figure 3. Stainless steel mesh can be used to provide physical barriers.

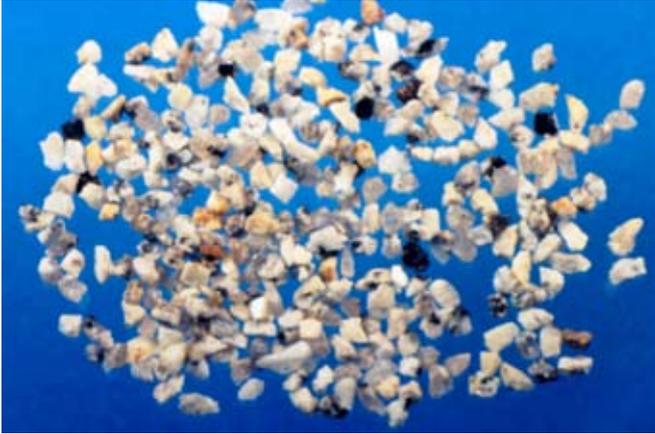
Figure 4. Graded stone barriers consist of compacted rock particles.

Stumps can be protected in-ground by graded stone barriers (Figure 4). The graded stone barriers consist of compacted rock particles of such a size (1.7–2.4 mm in diameter) that the termites cannot crawl between them, nor move them. Stone barriers are effective against *Coptotermes* spp. Further testing is required before a suitable particle size can be recommended for protection against other species of termite, especially the giant northern termite.

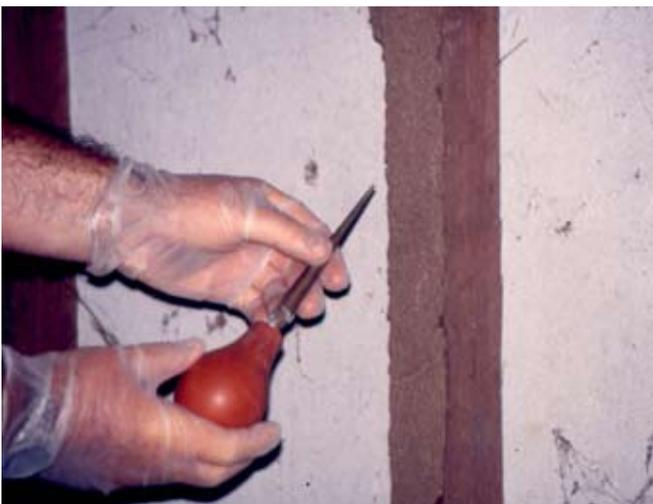
Figure 6. Toxic dust can be used to destroy the termite colony.

Toxic dust can be used to destroy a termite colony even when the nest has not been located (Figure 6). The treatment can be carried out only by an experienced operator licensed to obtain and use the dust.

The fine, dry dust (usually arsenic trioxide, fipronil, permethrin or triflumaron) is blown into occupied galleries by means of a hand blower. The dust adheres to the bodies of passing termites and is distributed into the colony. Arsenical dusting is ineffective against some species of termite, for example *Coptotermes frenchi*, which tend to avoid disturbed areas. Alternatively, termites may be aggregated using susceptible timber, removed, dusted and then returned to the site of activity to spread the dust through the colony. Boxes containing corrugated cardboard and susceptible timber, placed in the soil near termite activity, can facilitate aggregation. For these methods to be effective and safe, operator skill is required to judge the quantity of the dust needed and its placement.
